TITAN 1

FLIGHT DATA REPORT

Update published, April 2016

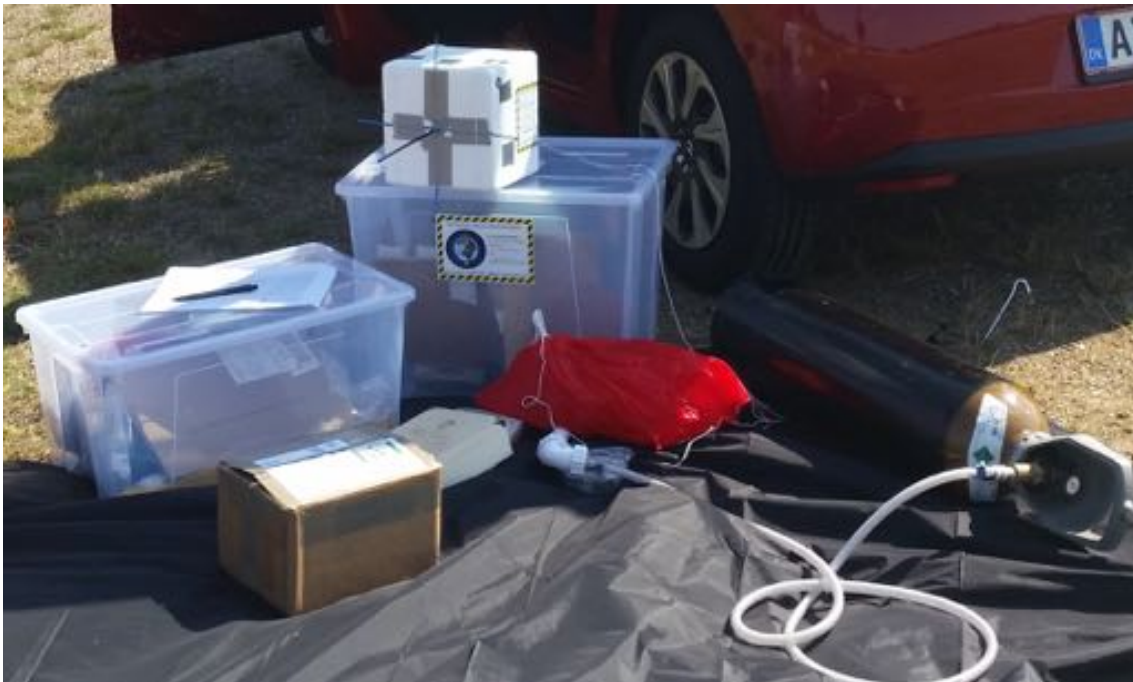
Figure 2: Titan 1 and equipment prepared for balloon inflation and launch.

control stated free to go, the equipment was unpacked and everything prepared for balloon inflation and launch. Fig. 2 shows Titan 1 after startup and with hatch already sealed. Before sealing the hatch transmission and image capturing was checked carefully.

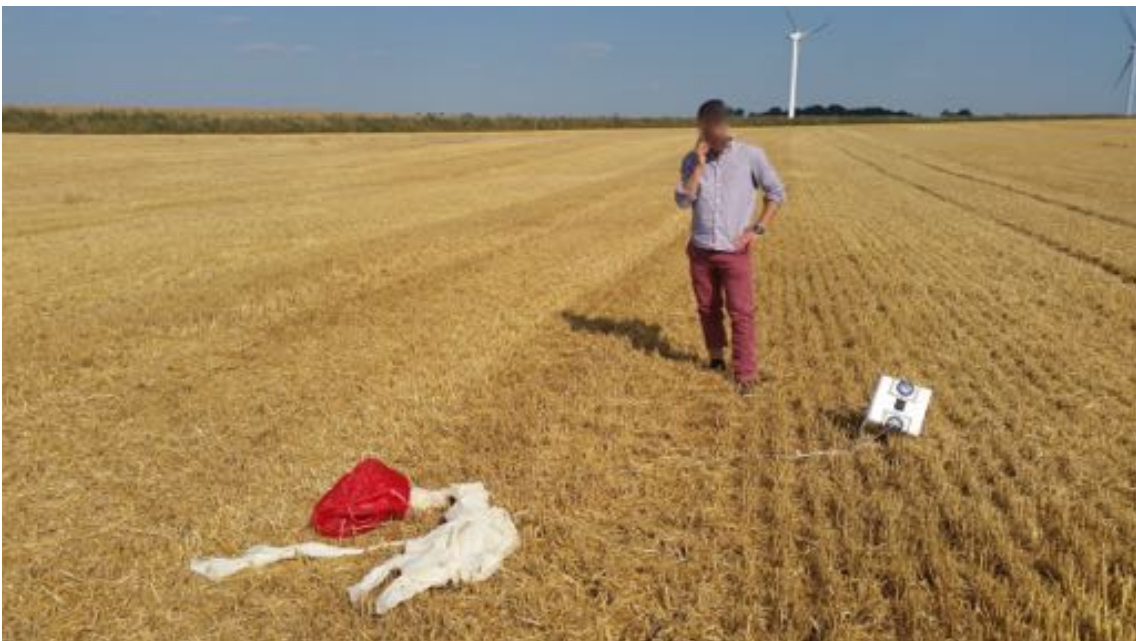
Figure 5: Titan 1 on landing site before recovery. Head of mission is talking to air traffic control to confirm touchdown and recovery.

At 14:03:57 UTC Titan 1 was spotted after tracking it from search position **S1** (see Fig. 10) and moving to search position **S2** (see Fig. 10). Titan 1 landed in a recently harvested field and could luckely be recovered with ease.

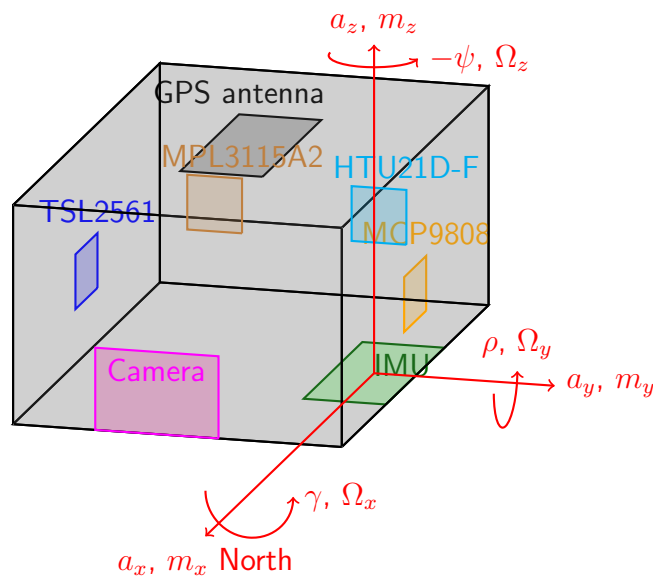
Figure 6: Schematic of payload box with sensor location and coordinate system of the IMU sensor.

As relevant to better understand the individual sensor readings, a schematic view of the payload box is shown in Fig. 6. Of special importance is the coordinate system of the IMU sensor.

During descent through the upper atmosphere the payload box is rolled to the left and and pitched up. I.e. the corner where the IMU sensor is located is lower than the opposite corner and the camera is looking up, see Fig. 6.

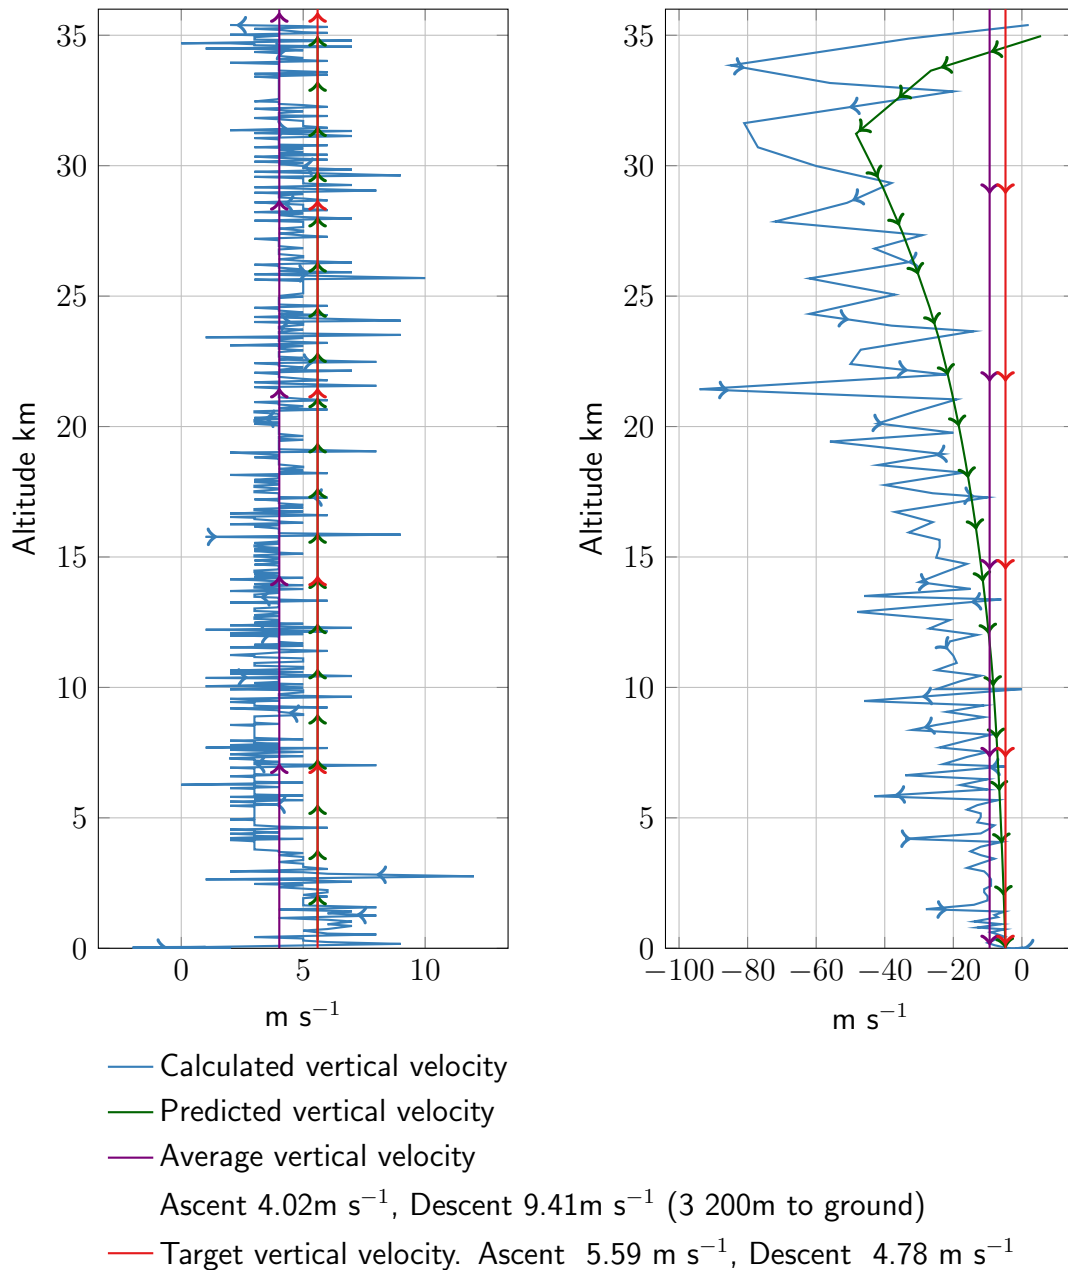
Figure 7: Vertical velocity during ascent (plot on the left) and during descent (plot on the right) calculated from GPS altitude.

Based on the GPS altitude $maxalt$ the vertical velocity was calculated, see Fig. 7. For the plot the coordinate convention as defined in the Design and Mission Documentation was used, ascent movement positive, decent movement negative, see coordinate system in Fig. 6.

The faster descent is caused partly by the additional weight of the remains of the burst balloon m_B which is 920 g and the fact that the lines got wrapped around the parachute's line, see Fig. 8. When looking at Fig. 7 it becomes clear that the descent velocity (not surprisingly) reduced as more Titan 1 descent into denser atmospheric layers. Thus, the average descent velocity is taken only for 3200 m altitude to ground.

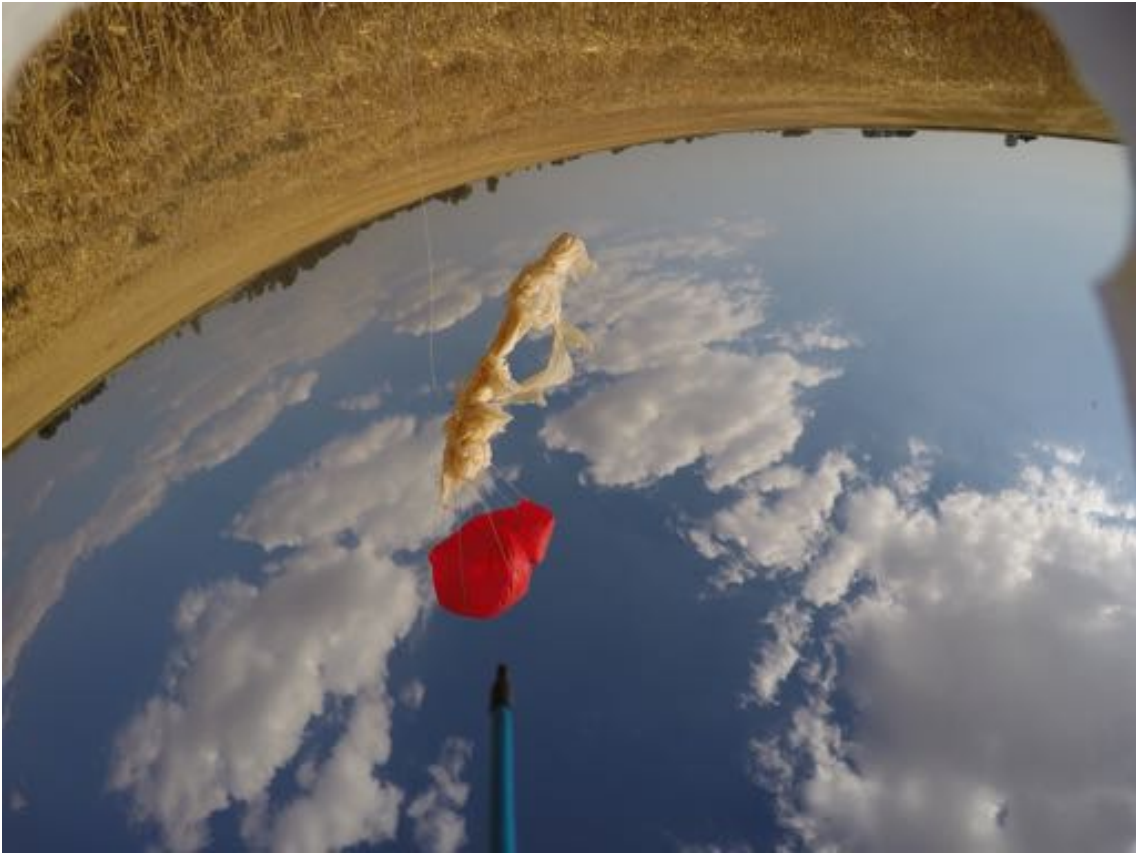
Figure 8: Titan's parachute with balloon remains wrapped around the parachute's lines. This image proves that the parachute opened during descent, even if not fully.

The parachute opening diameter $d_{P,real}$ was chosen with 0.700 m to fit the average descent velocity of 9.41 m s^{-1} . Comparing with the parachute opening in Fig. 8 the value seems about correct. Some more discussion regarding descent behaviour is given in section 8.

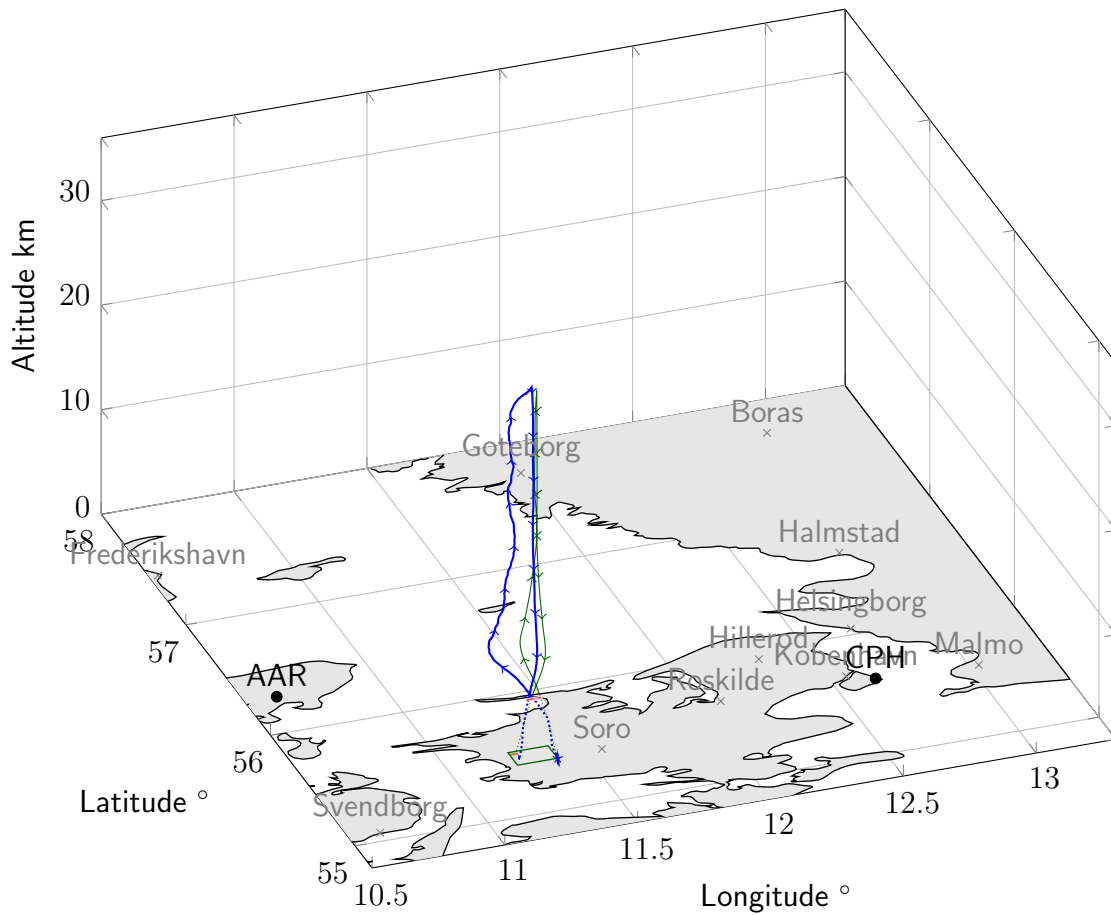
Figure 9: Isometric view of real flight path and predicted flight path. For reference all details send to the air traffic control are included as well.

In section 3.5.1 the ascent velocity and in section 3.5.2 the descent velocity were discussed. These two values are fundamental in order to understand deviations from the flight path documented in Fig. 9, Fig. 10 and Fig. 11.

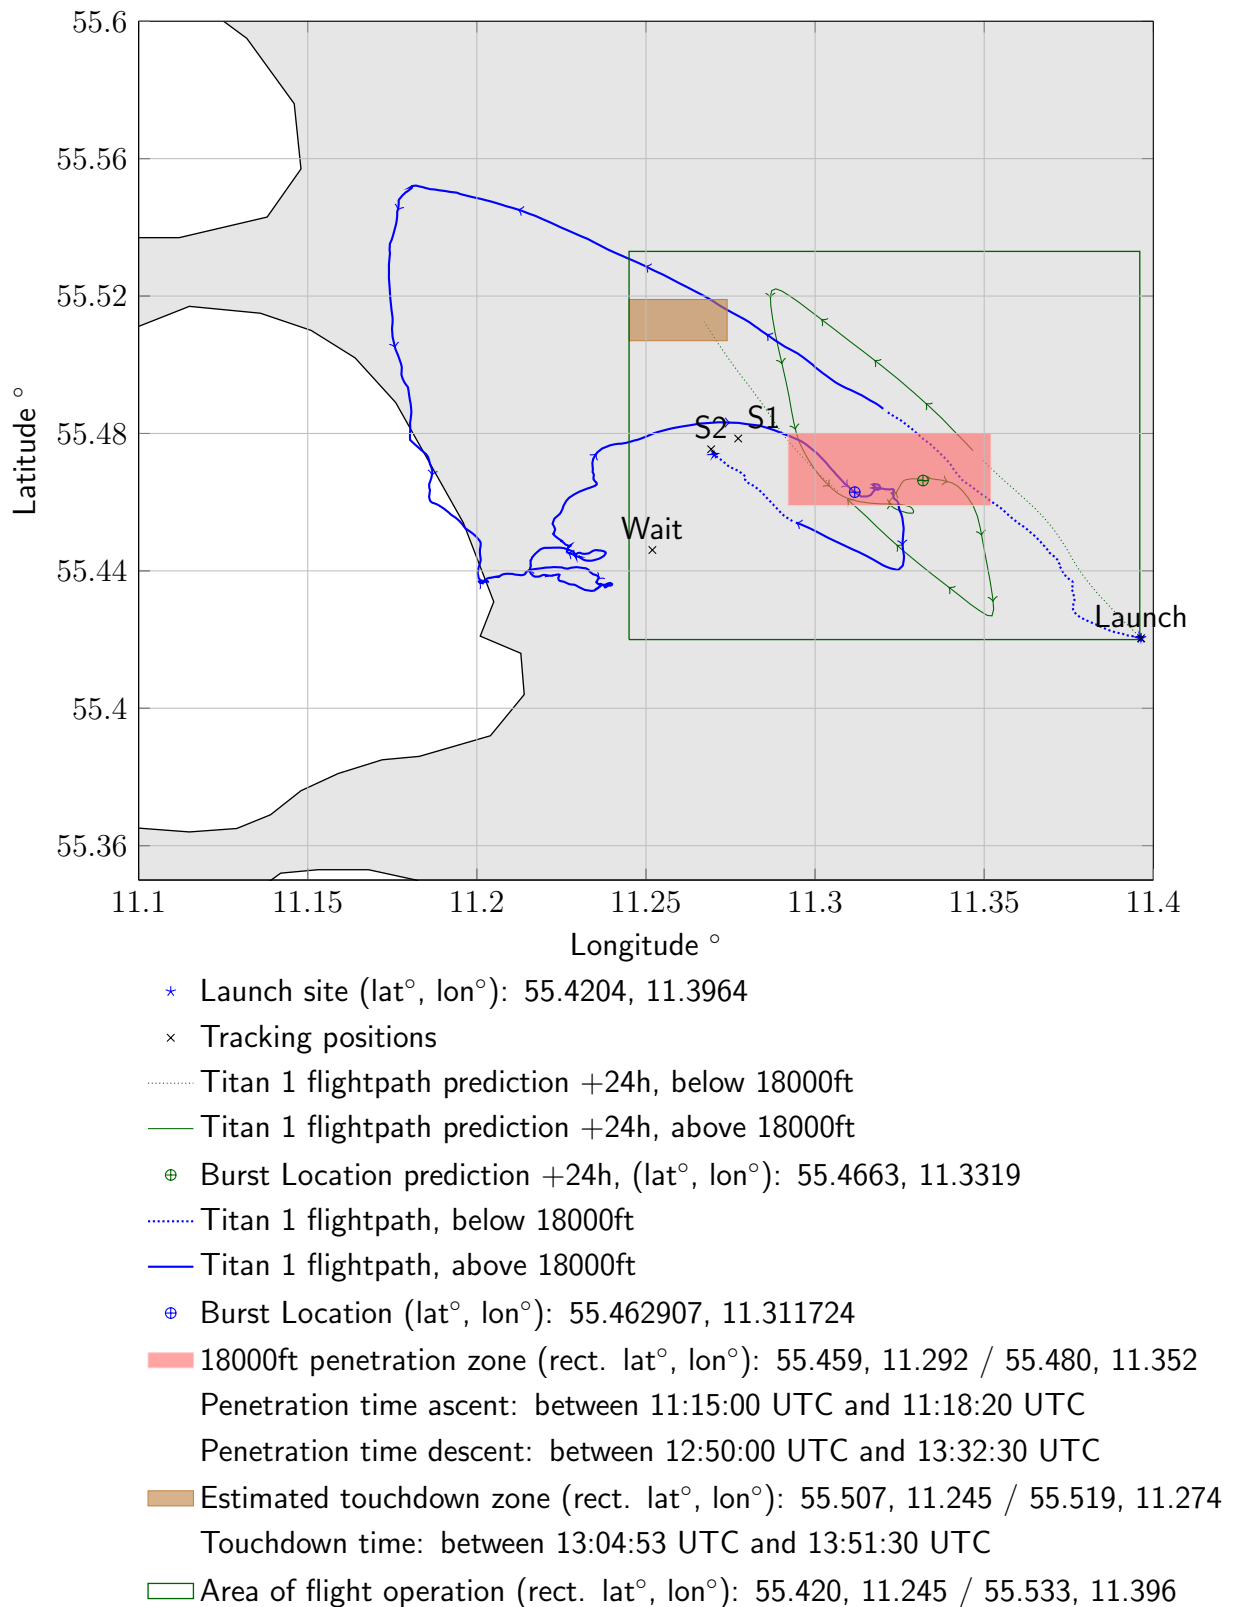
Figure 10: Top view of real flight path and predicted flight path. For reference all details send to the air traffic control are included as well and the tracking positions.

Staring with Fig. 10 allows to get a fast inside into what caused deviations from the

perdition to the actual flight path. As the balloon ascent much slower the ground winds dragged the balloon much farer north west. Notice however, how well the direction is aligned between prediction and flight path, see Fig. 12.

balloon nearly straight south. Again farer as the prediction as the balloon remains longer in the altitude range of the jet stream. Once above the jetstream the balloon movement is characterised by small high atmosphere movements dragging Titan 1 west east, especially above 30 000 m. See again Fig. 11 right plot were this observation becomes clear. What we can see is that the burst location is very near to the predicted burst location, see Fig. 10.

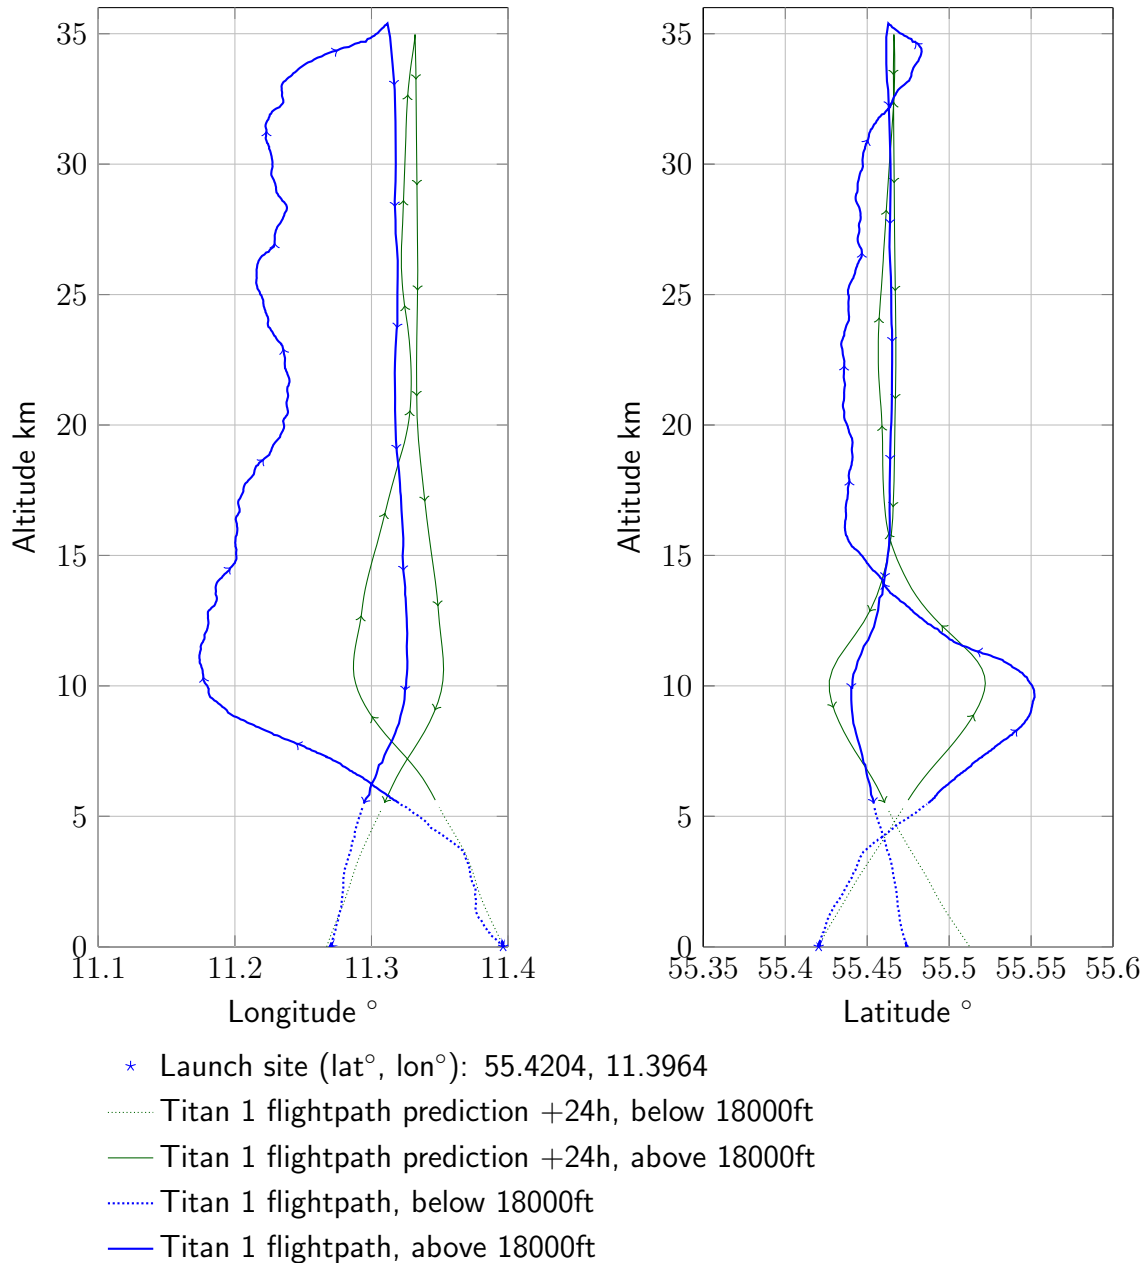
Figure 11: Side view of real flight path and predicted flight path.

Once reaching around 10 000 m, see also right plot in Fig. 11, the jetstream drags the

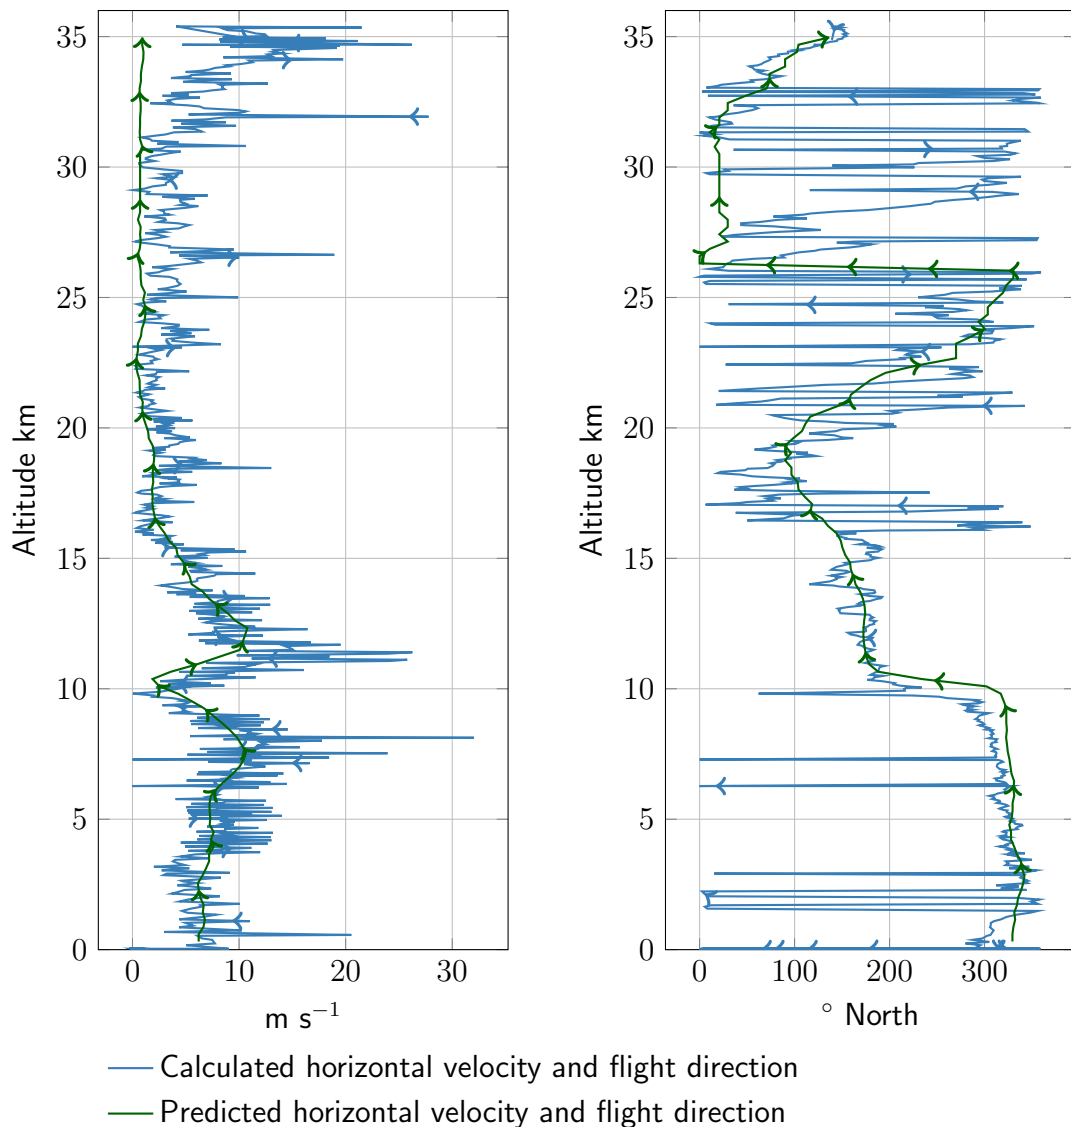
Figure 12: Horizontal velocity and direction of Titan 1 during ascent. For comparison also the predicted velocity and direction are shown.

Fig. 12 and Fig. 13 show very good agreement between the predicted Titan's fly velocity (Speed over Ground) and direction. As a comparison in terms of altitude takes the time out, this only proofs that the predicted wind velocity and direction for all altitude are considerable exact. Some smaller deviations can be found at altitudes above 25 000 m during ascent.

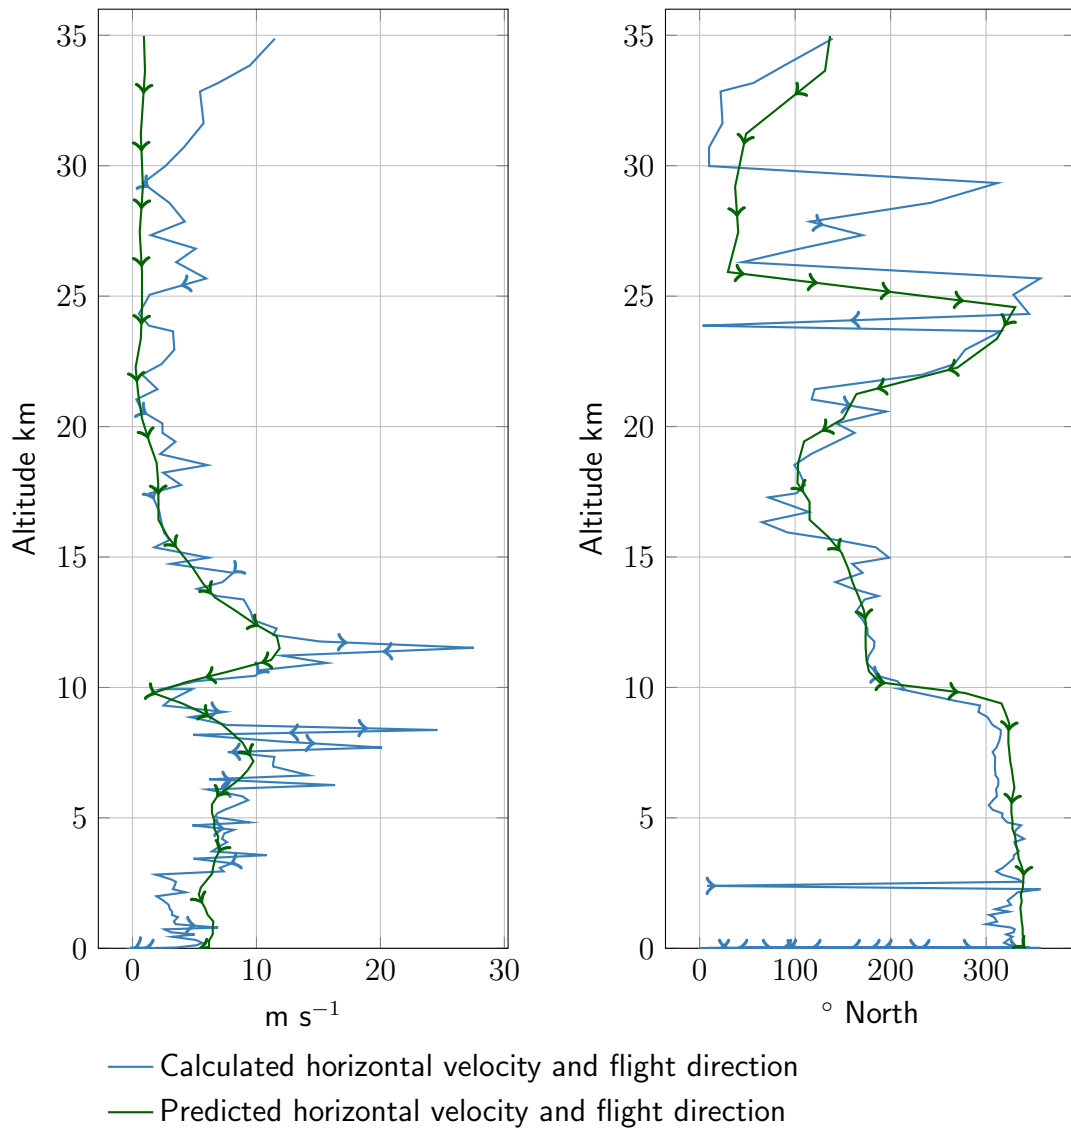
Figure 13: Horizontal velocity and direction of Titan 1 during descent. For comparison also the predicted velocity and direction are shown.

than in the prediction, see Fig. 13. This lead to Titan 1 touchdown more south than predicted.

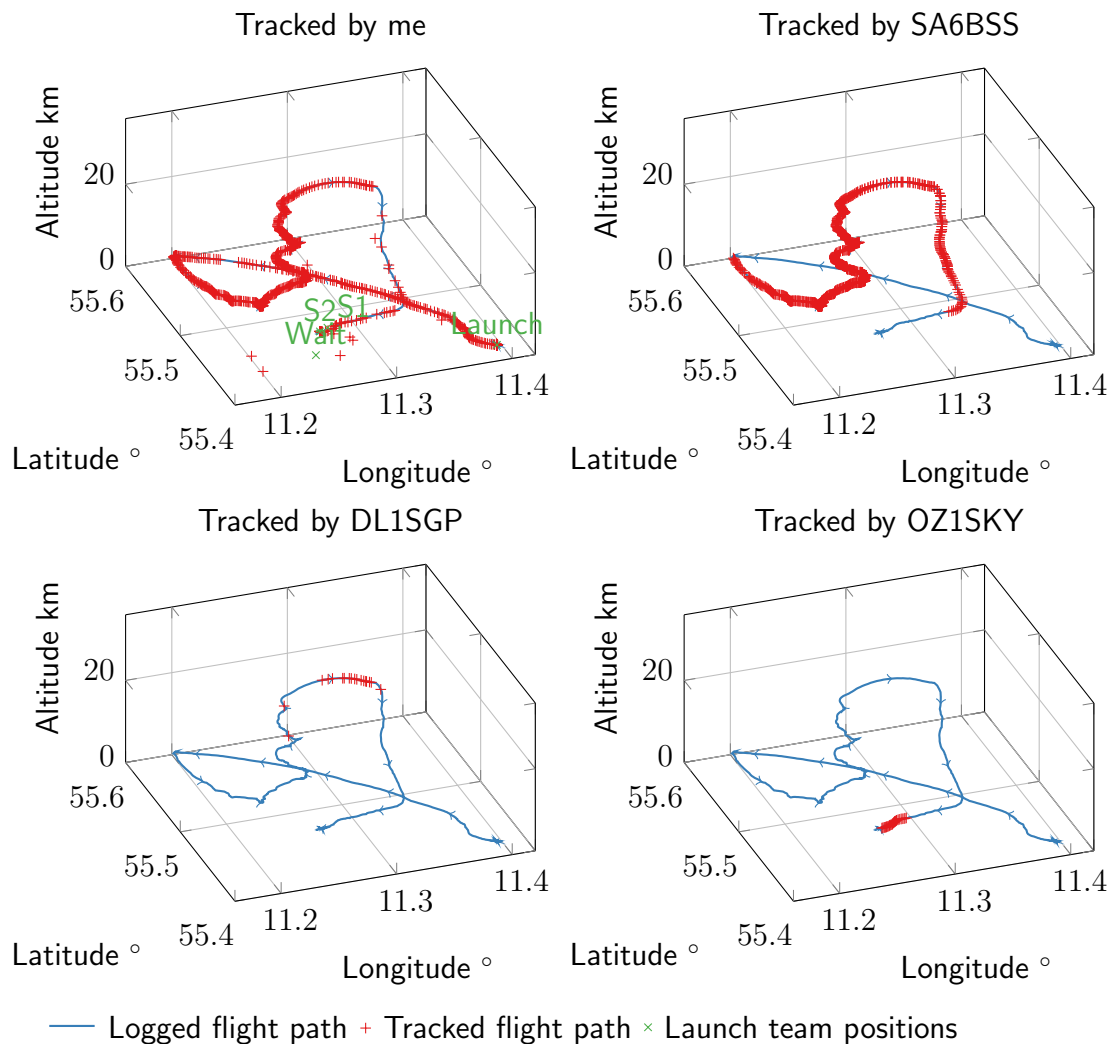
Figure 14: Logged flight path with tracked flight path of Titan 1. Plots are shown individually for the four trackers.

Fig. 14 shows the logged flight path and the positions tracked by the individual trackers. The positions of the launch team are shown as well for reference.

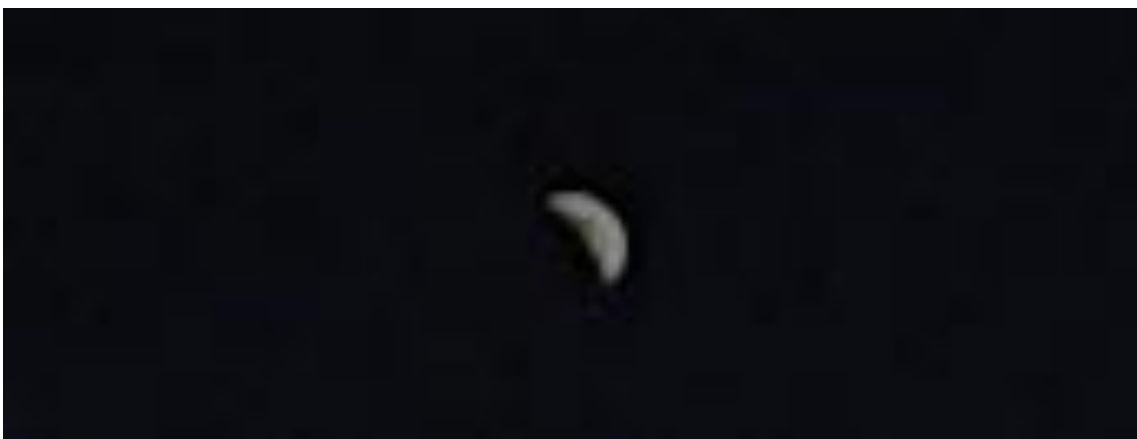
Figure 17: Magnification of the moon in Fig. 16. Remarkable is the darkness of space due to low light sensitive of the camcorder.

Fig. 17 shows a magnification of the moon as seen in Fig. 16. The waxing crescent of the

moon can be nicely observed. The resolution of the image is impressive, remember the distance to the moon is 398 887 km, as still the moon's dark spots can be identified.

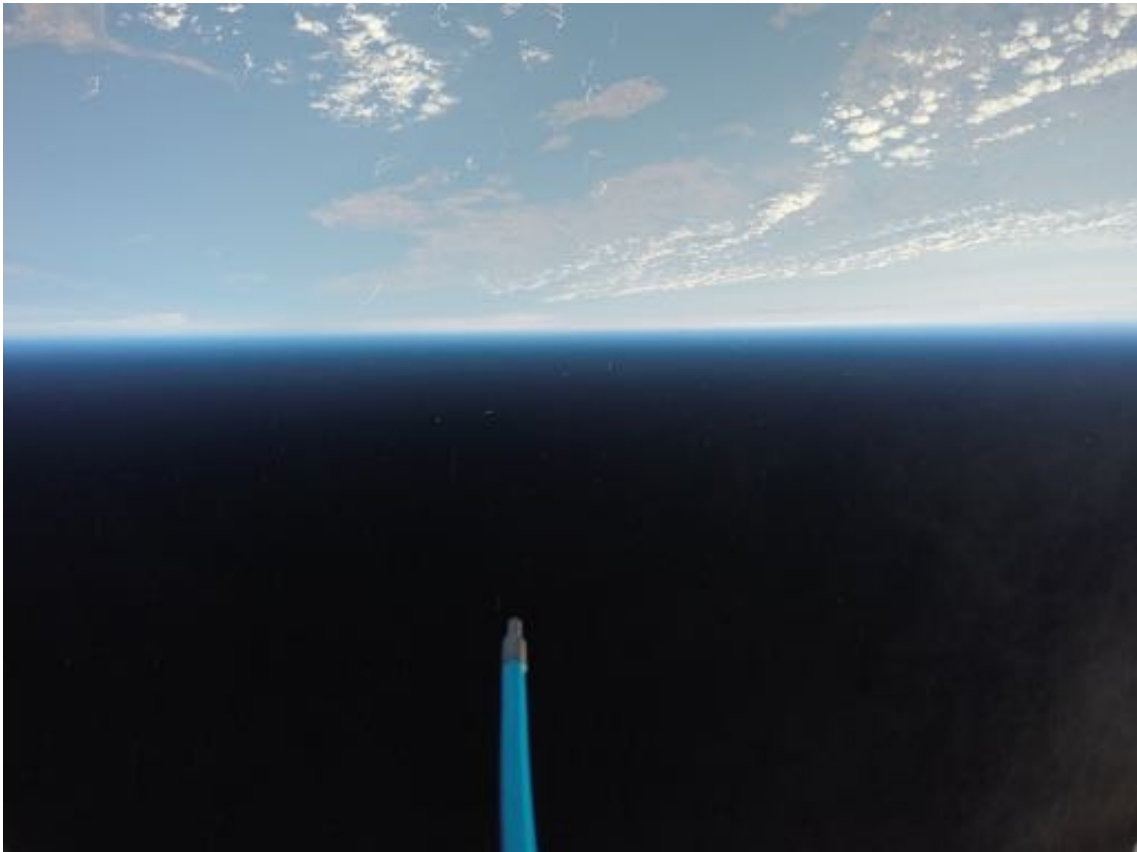
Figure 18: First image taken after burst of the balloon, Titan 1 ending upside down. Some fragments of the balloon can be seen. Image taken at 13:27:38 UTC.

The second major event, after the launch, is when the balloon bursts at peak altitude. The first image taken after the balloon's burst is shown in Fig. 18. Titan 1 ended up upside down before returning in normal flight position.

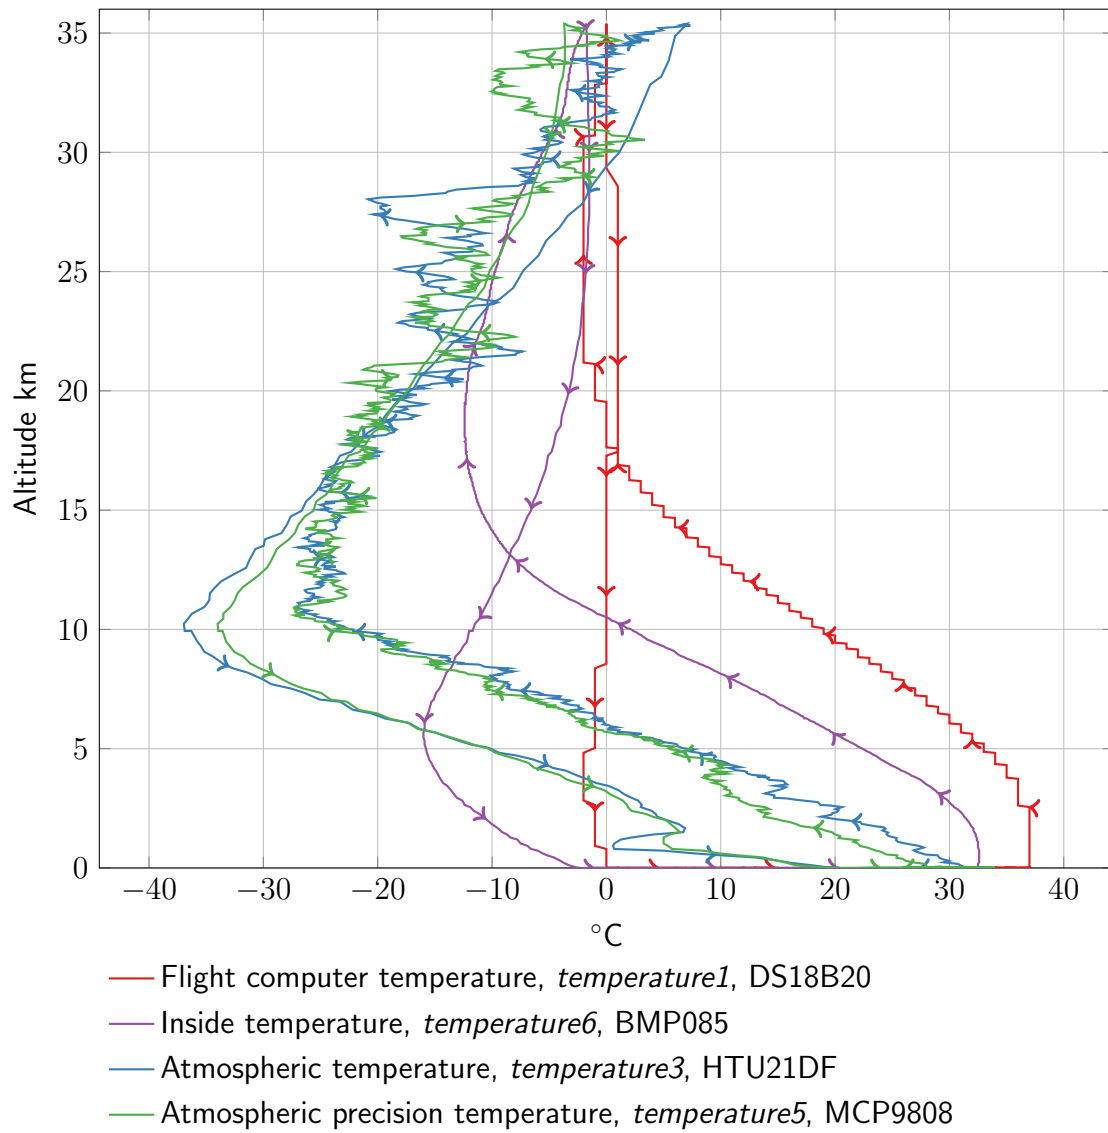
Figure 20: Temperature readings for different temperature sensors inside the payload box and on the outside.

Fig. 20 shows the external (atmospheric) and internal temperature. The external temperature is a little above of what would have been expected (minimum around -50°C) is probably due to the fact the sensors being exposed to sun light. In a future mission the sensors will be mounted without direct light impact. The internal temperature follows the external temperature with a time delay. The minimum flight computer is logged with -2°C .

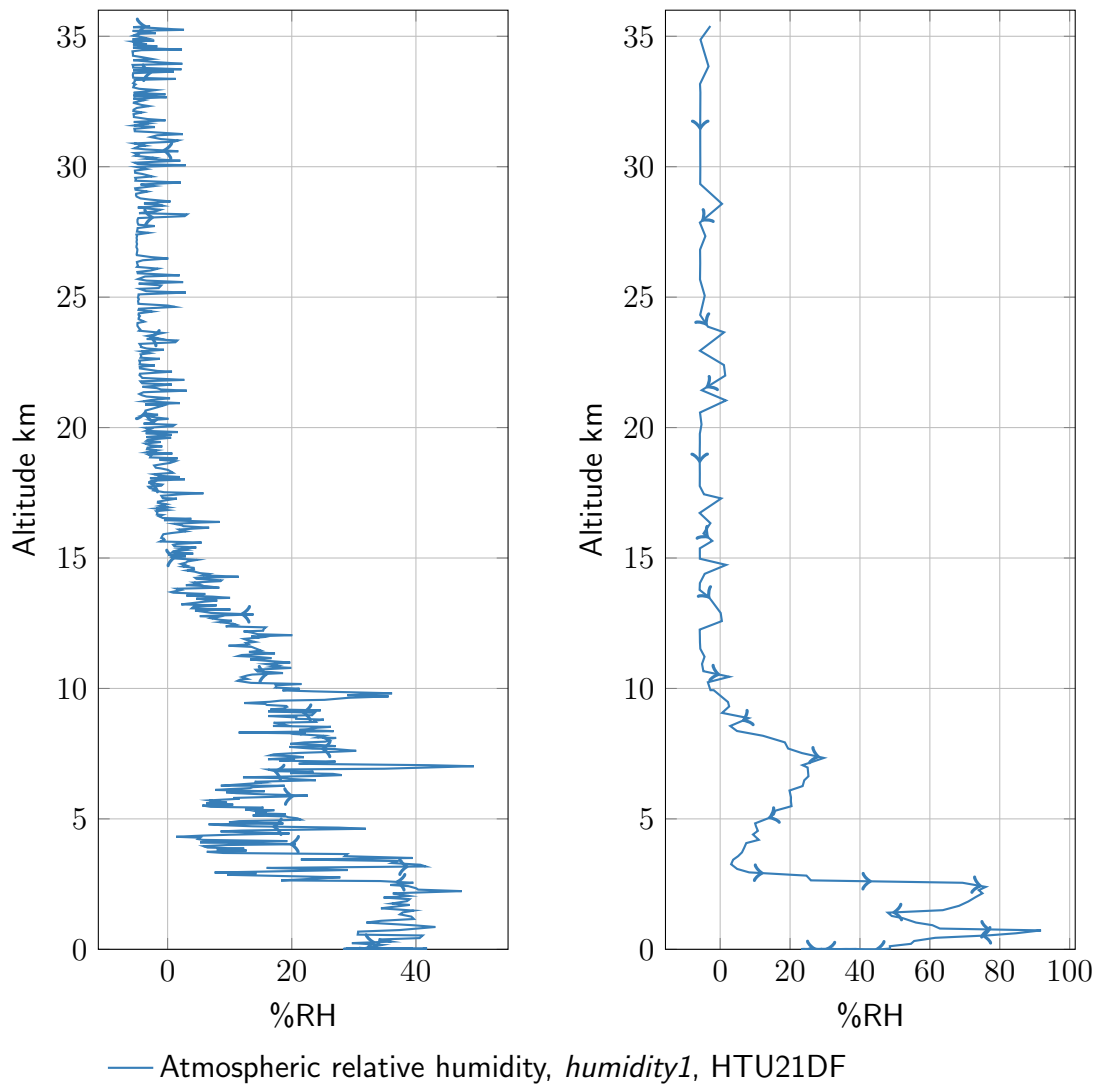
Figure 21: Relative humidity of the atmosphere without accounting for pressure correction.

The relative humidity of the atmosphere is measured with the HTU21DF sensor and results are shown in Fig. 21. The values are not corrected for the reduced pressure in altitude and thus resulting in a relative humidity below zero. Interesting however is that the cloud level (around 3200 m) can be sensed by increased relative humidity.

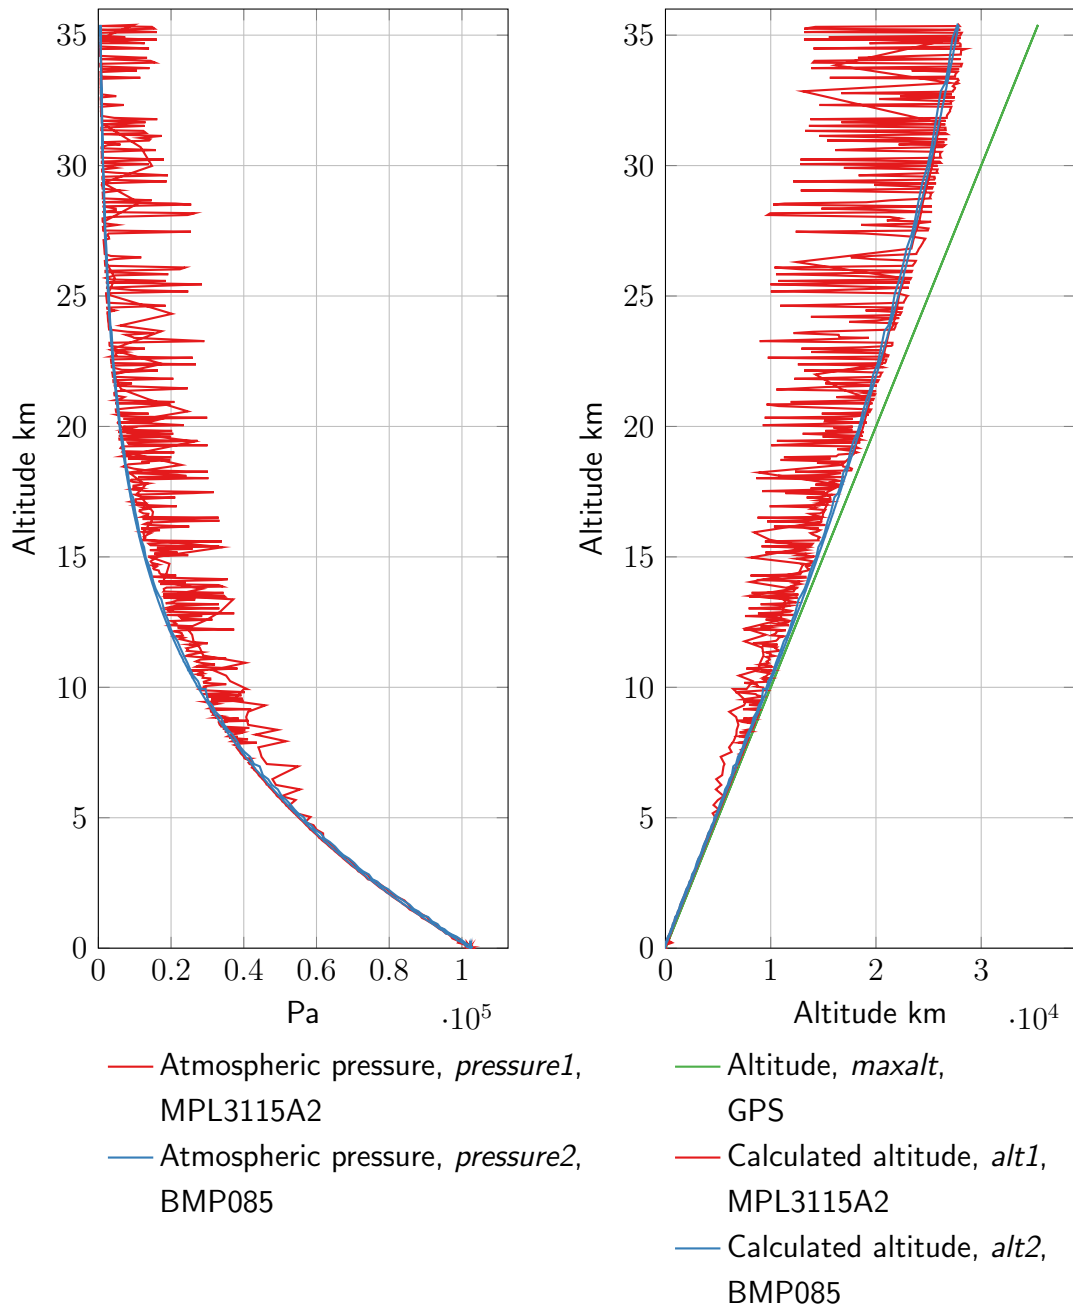
Figure 22: Pressure sensor readings and comparison of calculated altitude with actual GPS altitude.

The sensed pressure is shown in the left plot of Fig. 22 where as on the right plot in Fig. 22 the calculated altitude from the sensed pressure is compared with the GPS altitude. Unfortunately, the readings of the MPL3115A2 sensor are in parts ambiguous, but the indication of the pressure reduction gets clear. The BMP085 sensors gave very stable readings. However, for both sensors the atmospheric pressure gets too low (approximately 800 Pa at 35 000 m) to sense accurately. BMP085 sensor has a lower limit of 30 kPa and the MPL3115A2 sensor 20 kPa, for both much larger than the actual pressure.

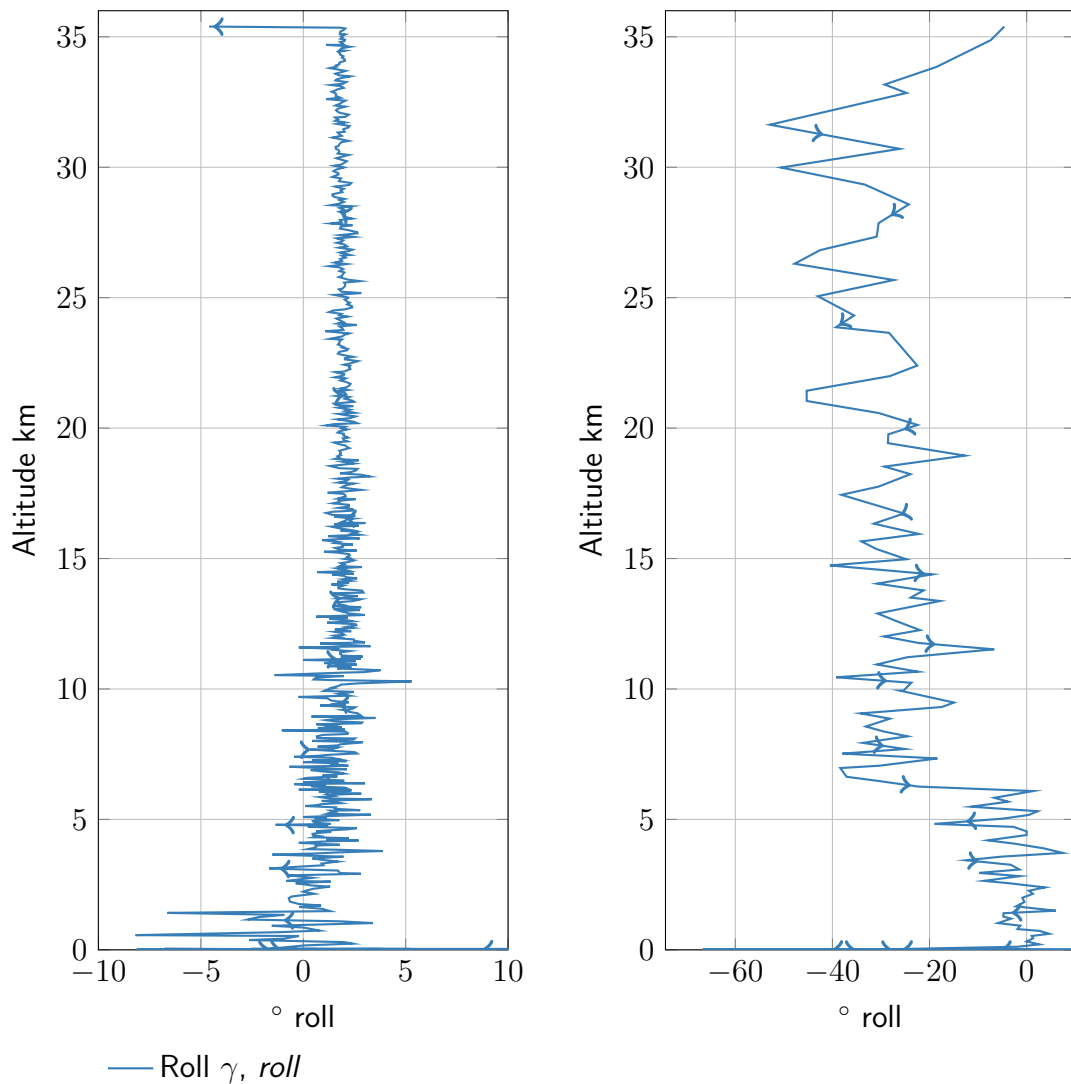
Figure 23: Roll of Titan 1's payload box during ascent and descent. Values derived from earth acceleration readings.

Looking at roll and pitch, it becomes clear that during ascent the payload box remained mostly horizontal. Some small mean angular deviation can be observed in Fig. 23 and Fig. 24, however it looks like they are caused by a sensor offset, see Fig. 36 as from the taken images it can be understood that the payload box was considerable horizontal.

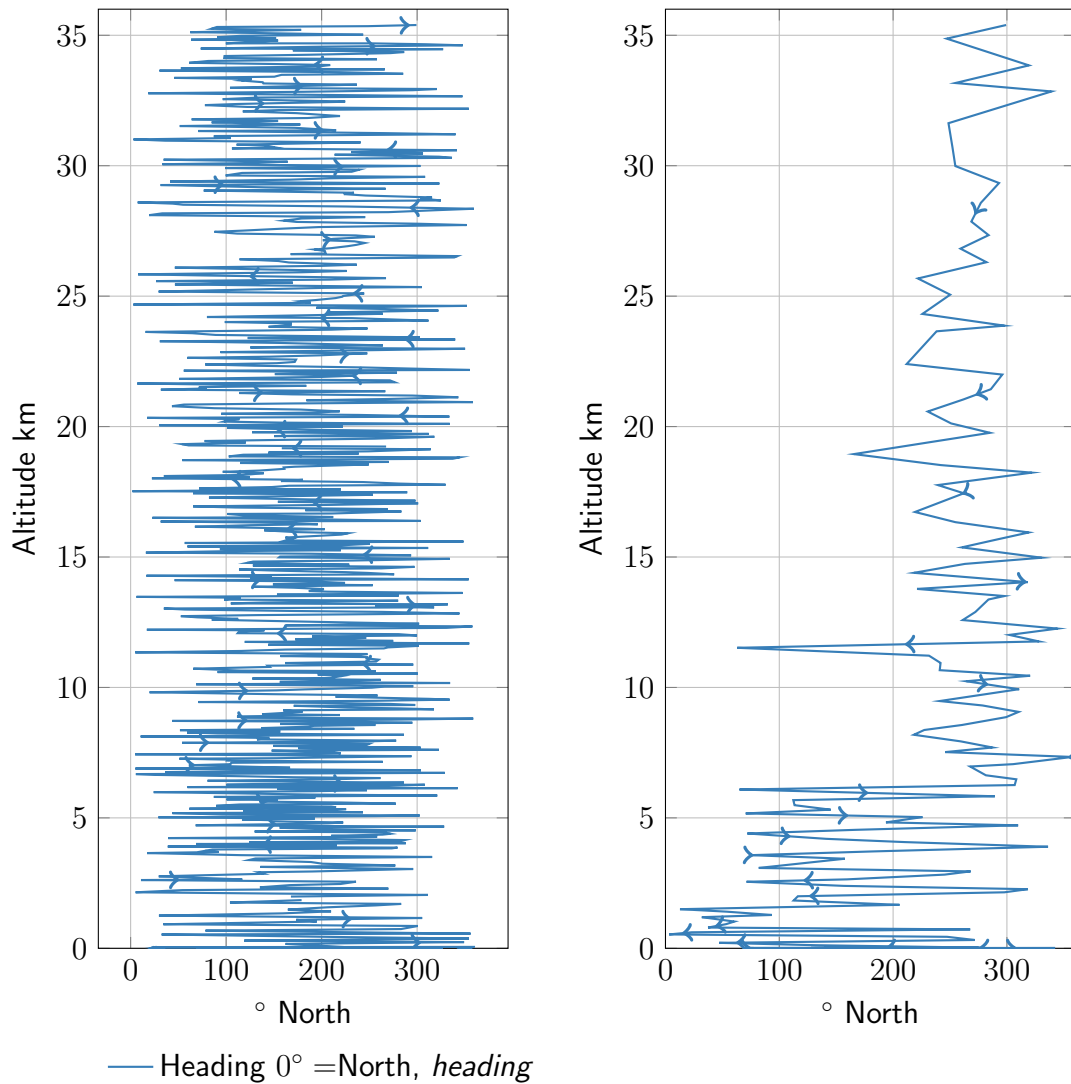
Figure 25: Heading of Titan 1’s payload box during ascent and descent. Values derived from earth acceleration readings and earth magnetic field.

As already pointed out the calibration of the magnetic sensor was done before driving to the launch site, this lead to a poorly calibrated magnetic sensor and thus to ambiguous heading values. However, the values are shown in Fig. 25. The heading becomes more interesting when compared to the vertical payload spin, see Fig. 27. The payload box rotates more or less in one direction and then rotates back, quite strong at the beginning but once reaching high altitude the angular velocity reduces. This, somehow proofs that the installed swivel increases rotational stability (less spin is transferred form the parachute and or balloon to the payload box) of the payload box. Further, this is confirmed by analysing the images taken by the camcorder.
