TITAN 1

FLIGHT DATA REPORT

Update published, April 2016

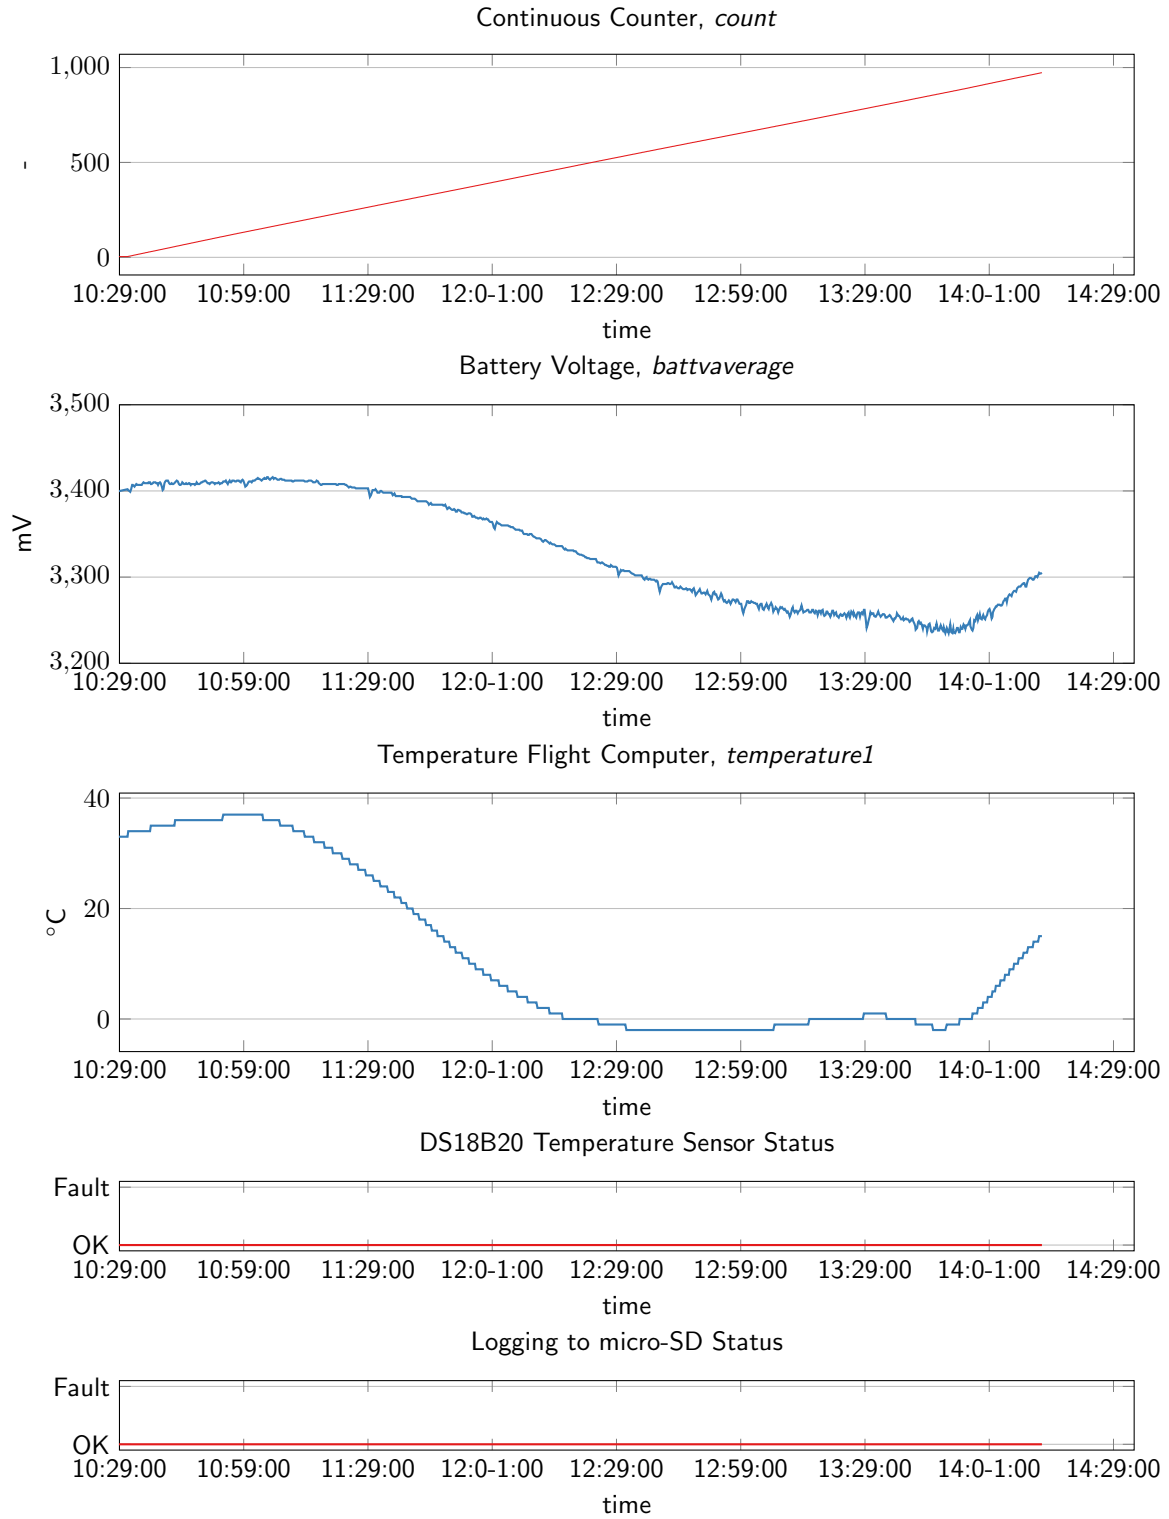
Figure 28: Raw logged data regarding flight computer. Last two plots flight computer temperature sensor status and logging status.

The flight computer operated throughout the mission without any problems. As the logged values for *count* in Fig. 28 confirm. In the same figure *battvaverage* is shown which proves that the power source was designed with good reserves, voltage drop is mostly due to temperature decrease. Flight computer minimum logged temperature (*temperature1*) was -2°C .

Data logging was operational throughout the whole mission, see Fig. 28 Logging to micro-SD Status.

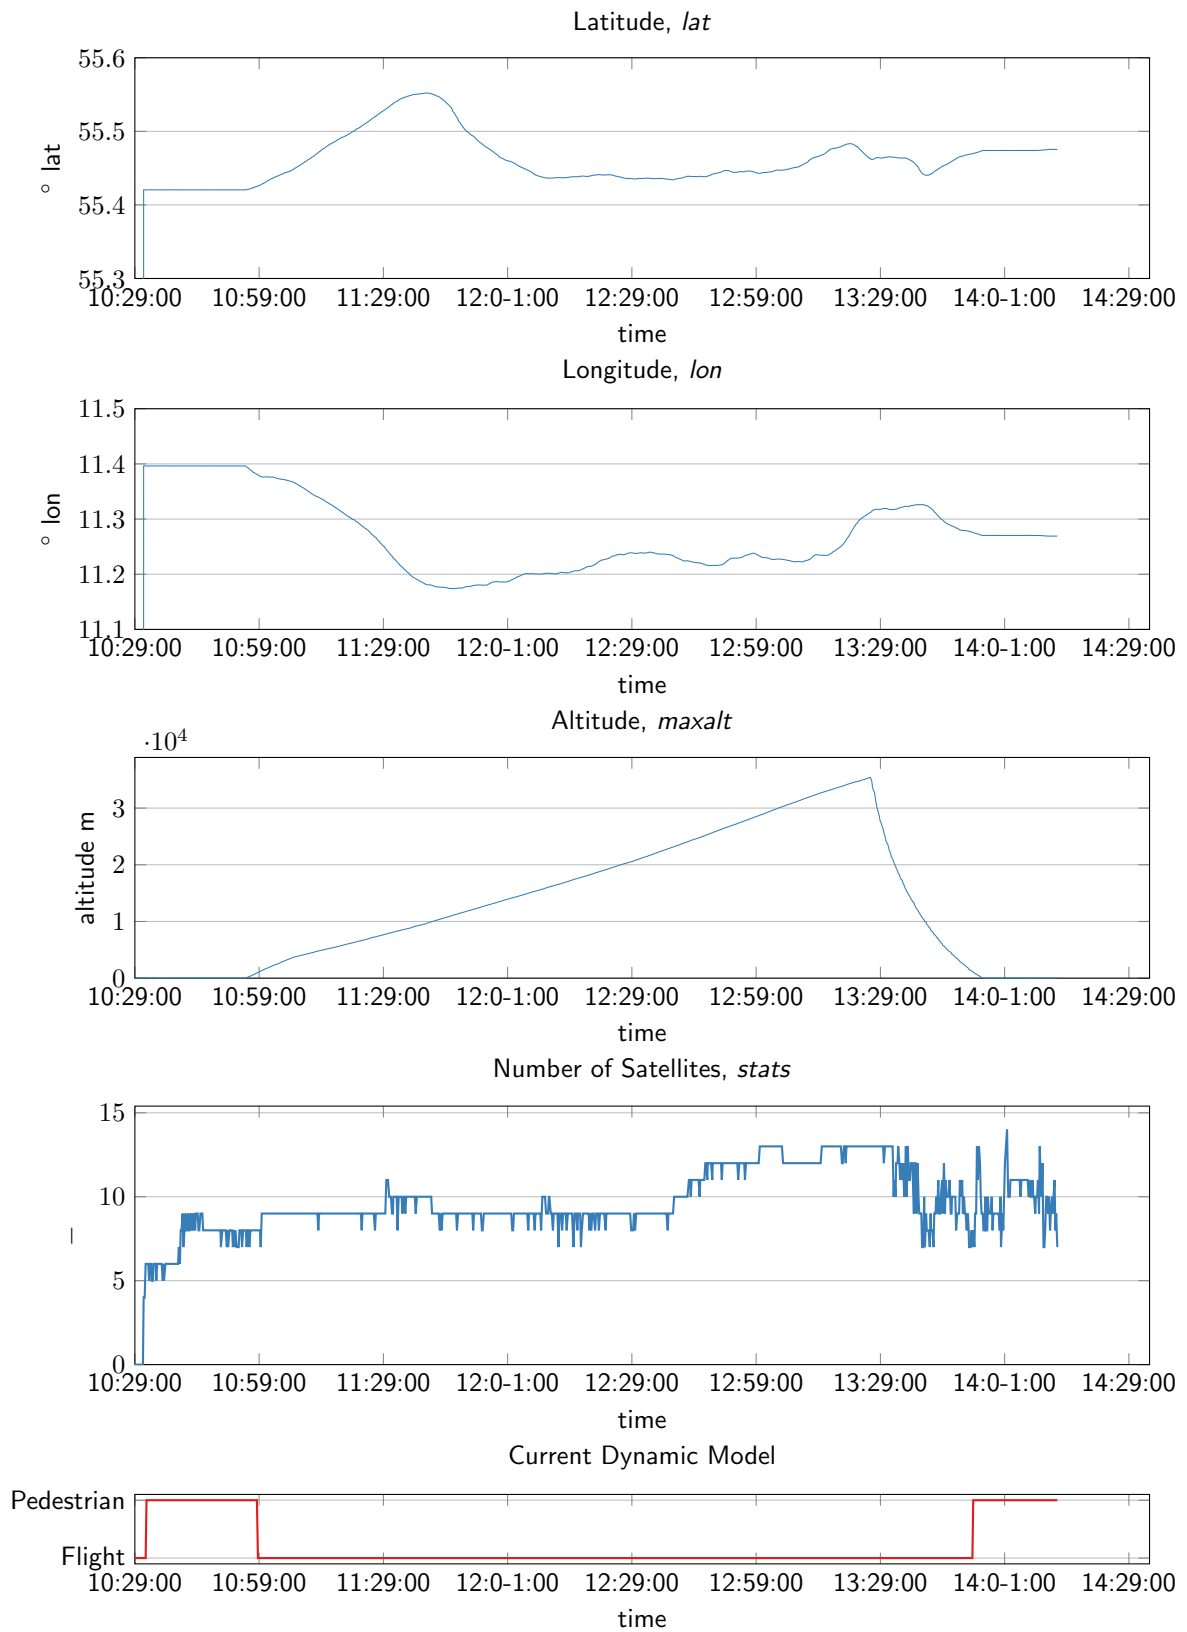
Figure 29: GPS logged location and number of satellites. Last plot GPS dynamic model.

GPS was nominal during whole mission, see Fig. 29 and Fig. 30. An important point is the smooth transmission from pedestrian to flight mode.

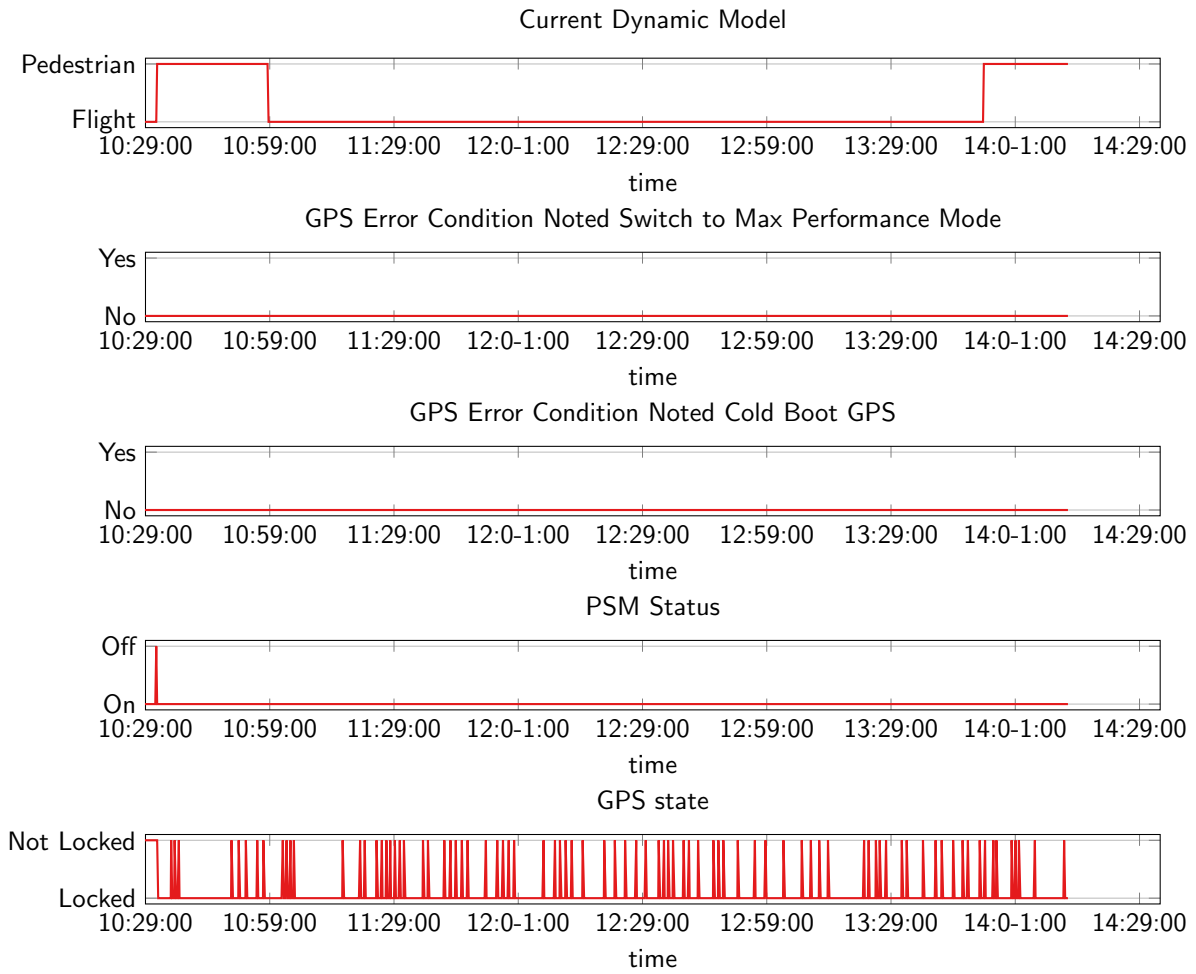
Figure 30: Raw logged data regarding various GPS states.

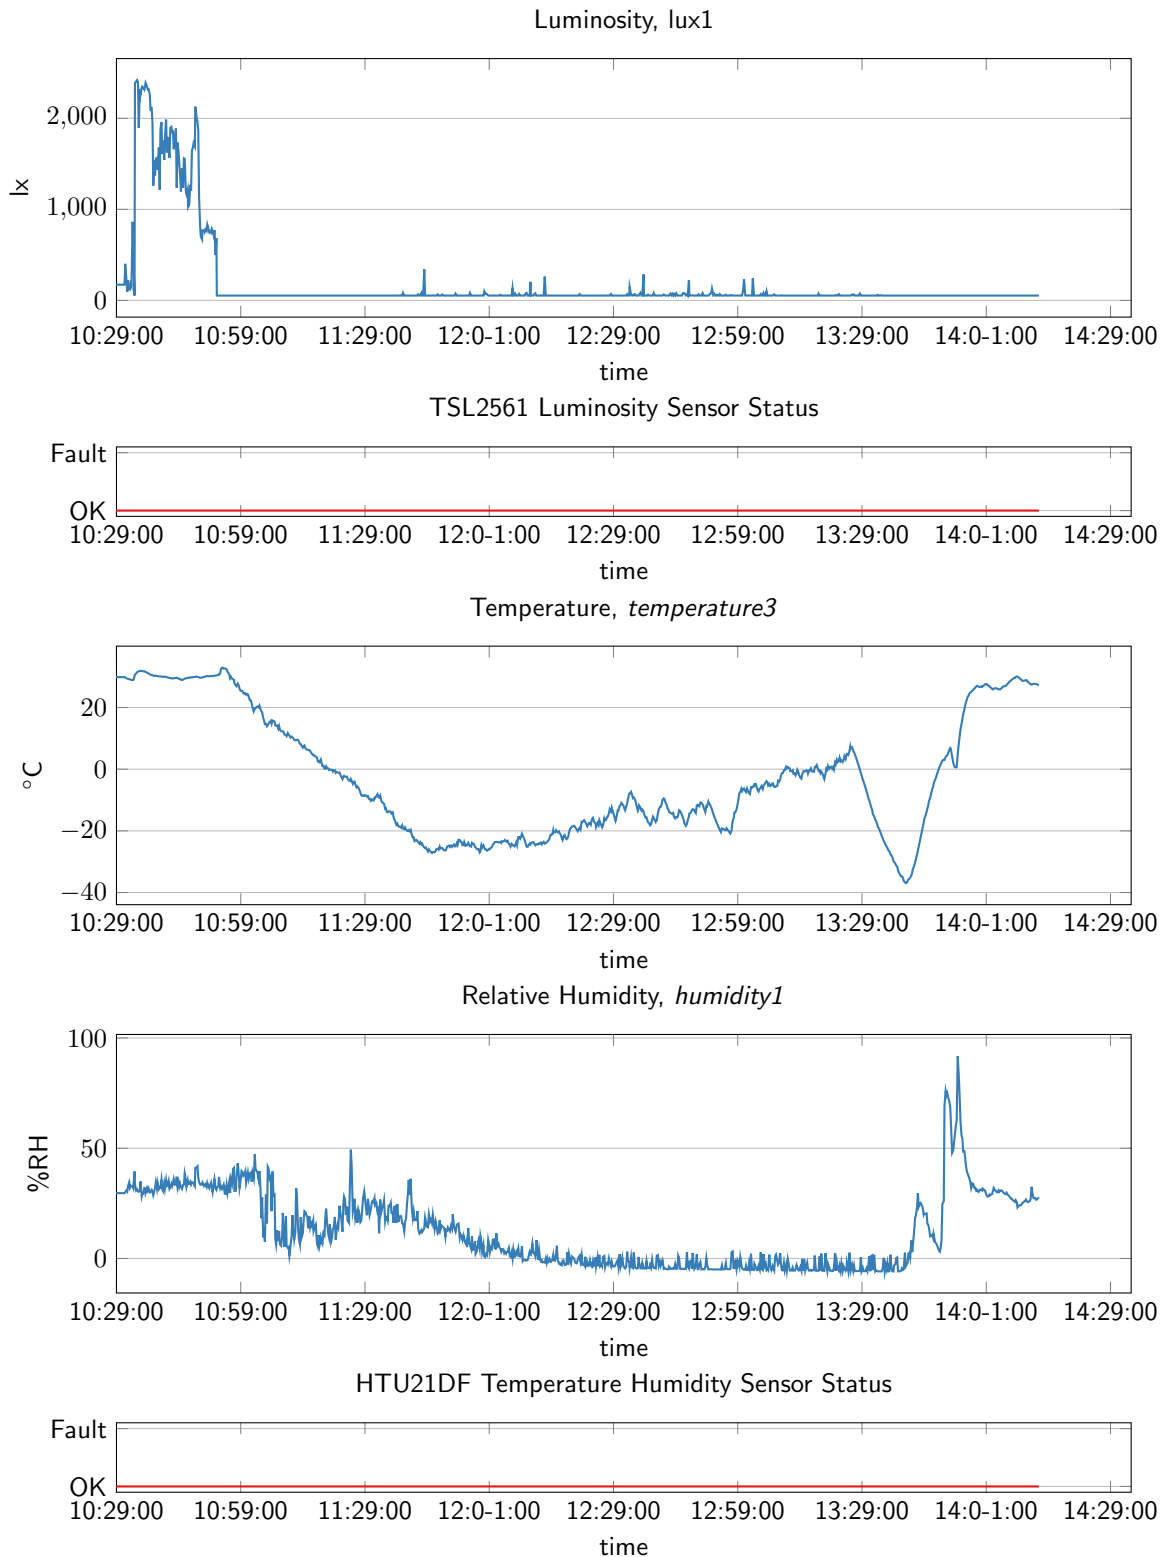
Figure 31: Raw logged data of luminosity, temperature and relative humidity sensors mounted on the outside of the payload box. Second and last plot according sensor status.

Tests conducted after the flight with the luminosity sensor TSL2561 resulted in following explanation for the errors readings. It seems as if too strong light hits the sensors it get saturated resulting in an ambiguous reading of 53 lx, see Fig. 31.

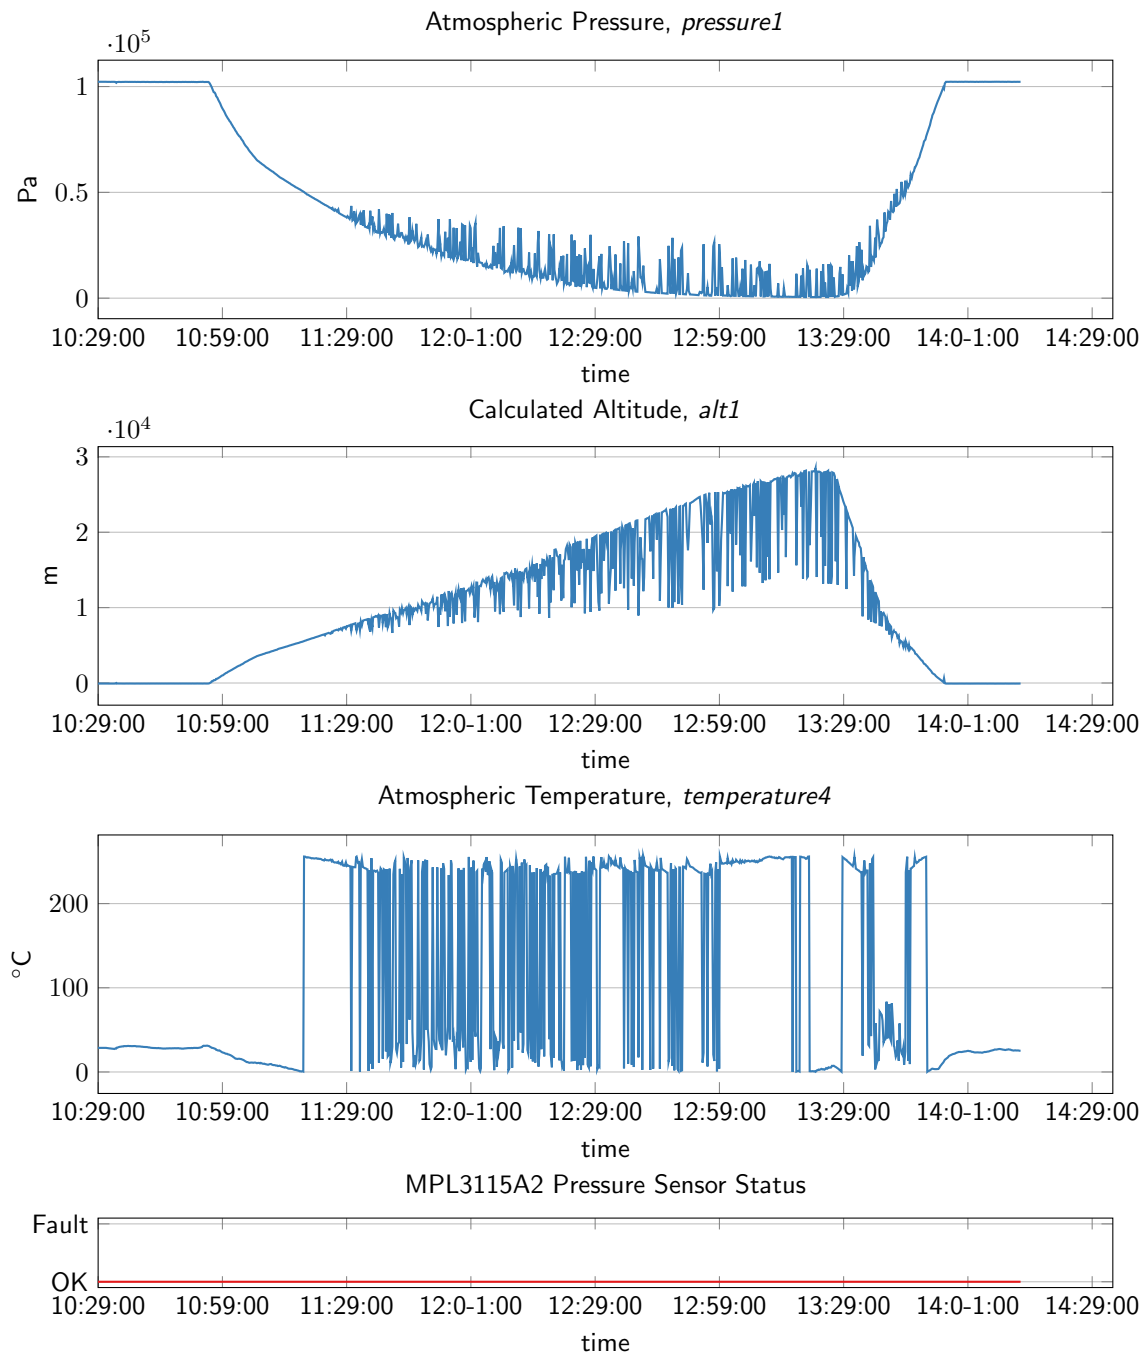
Figure 32: Raw logged data of MPL3115A2 pressure sensor mounted on the outside of the payload box. Last plot sensor status.

What caused the strange jumps and errors in the MPL3115A2 pressure and temperature readings is not fully clear. However, it looks like reading from the sensor is not done correctly, this holds particularly for the temperature reading where temperature values below zero are all ambiguous, whereas positive temperatures are shown correctly, see Fig. 32.

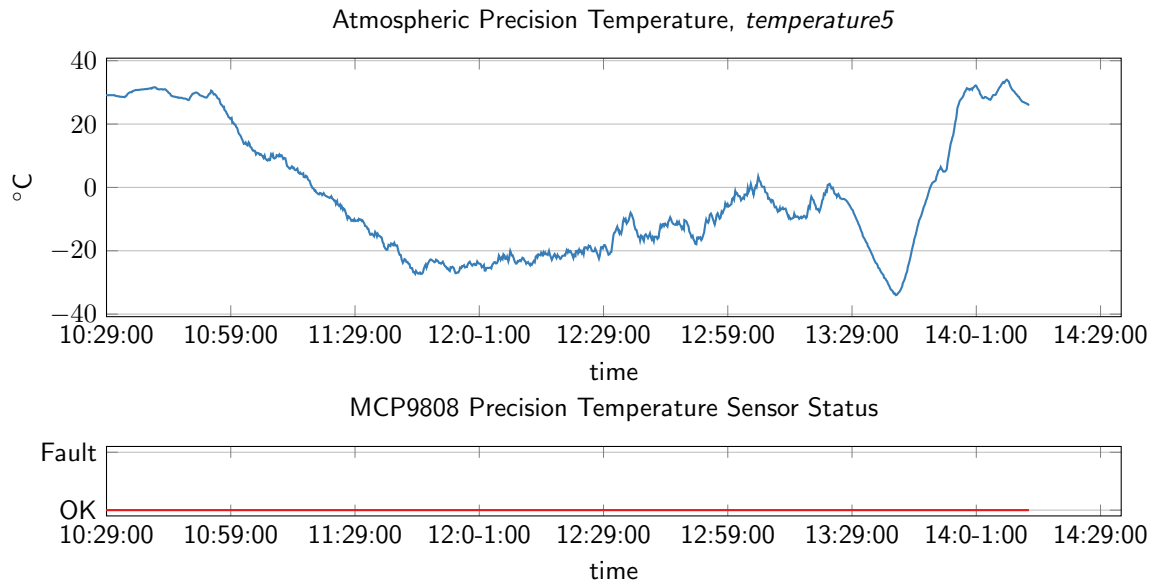
Figure 33: Raw logged data from precision temperature sensor. Last plot sensor status.

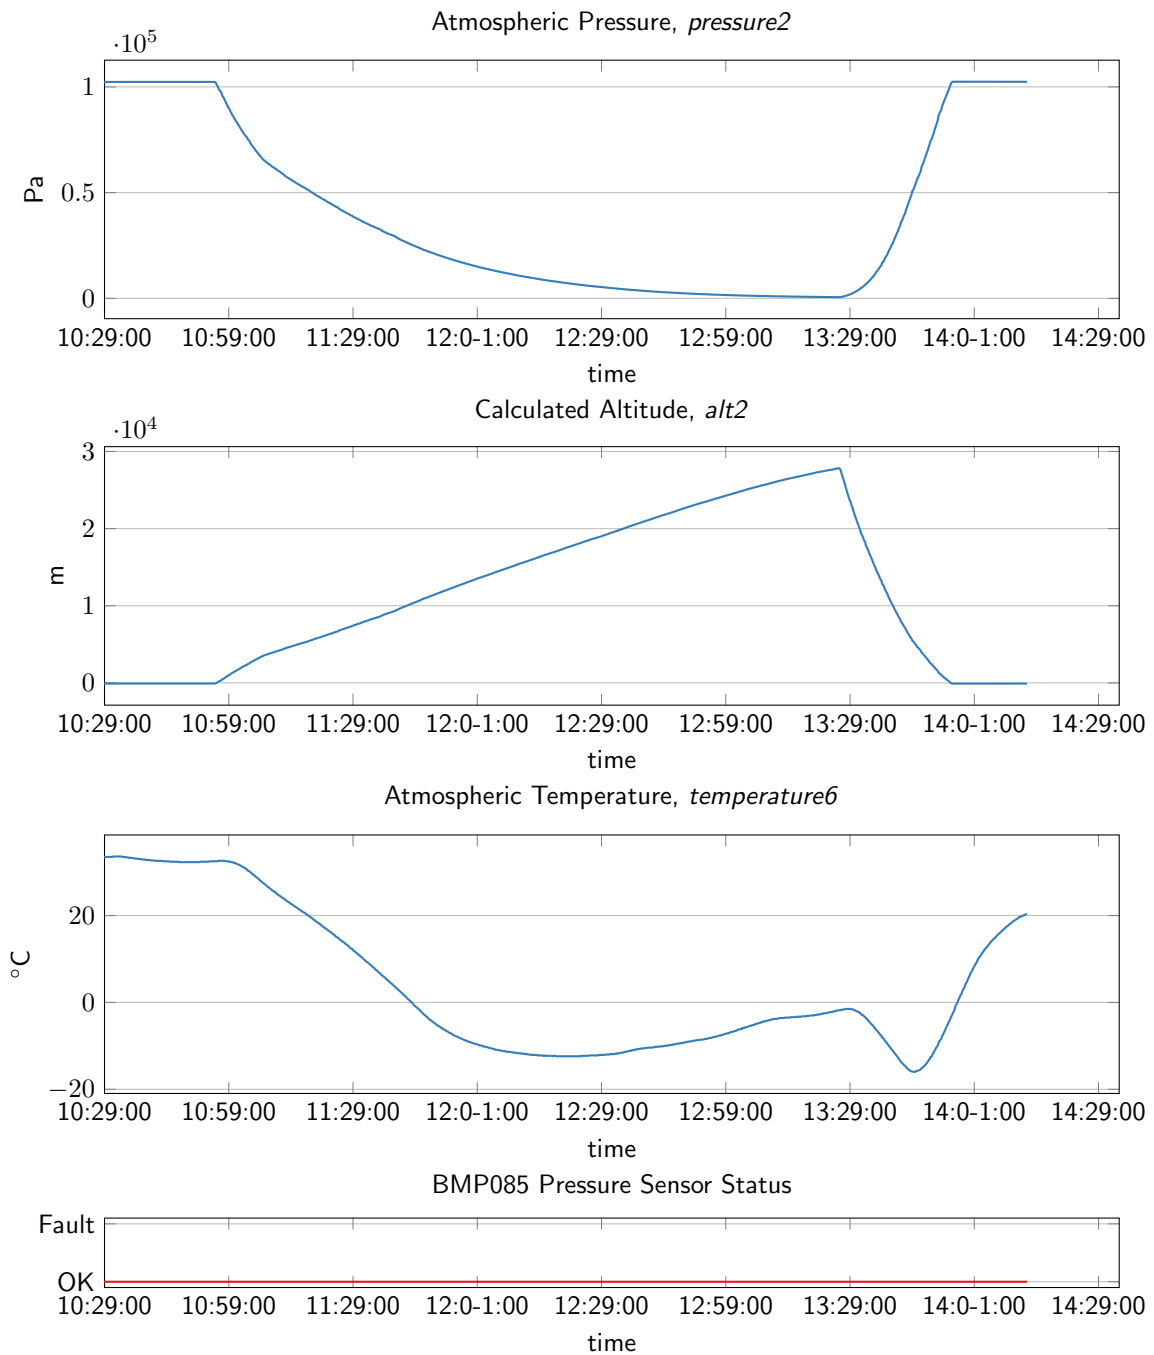
Figure 34: Raw logged data of BST-BMP180 pressure sensor mounted on the inside of the payload box. Last plot sensor status.

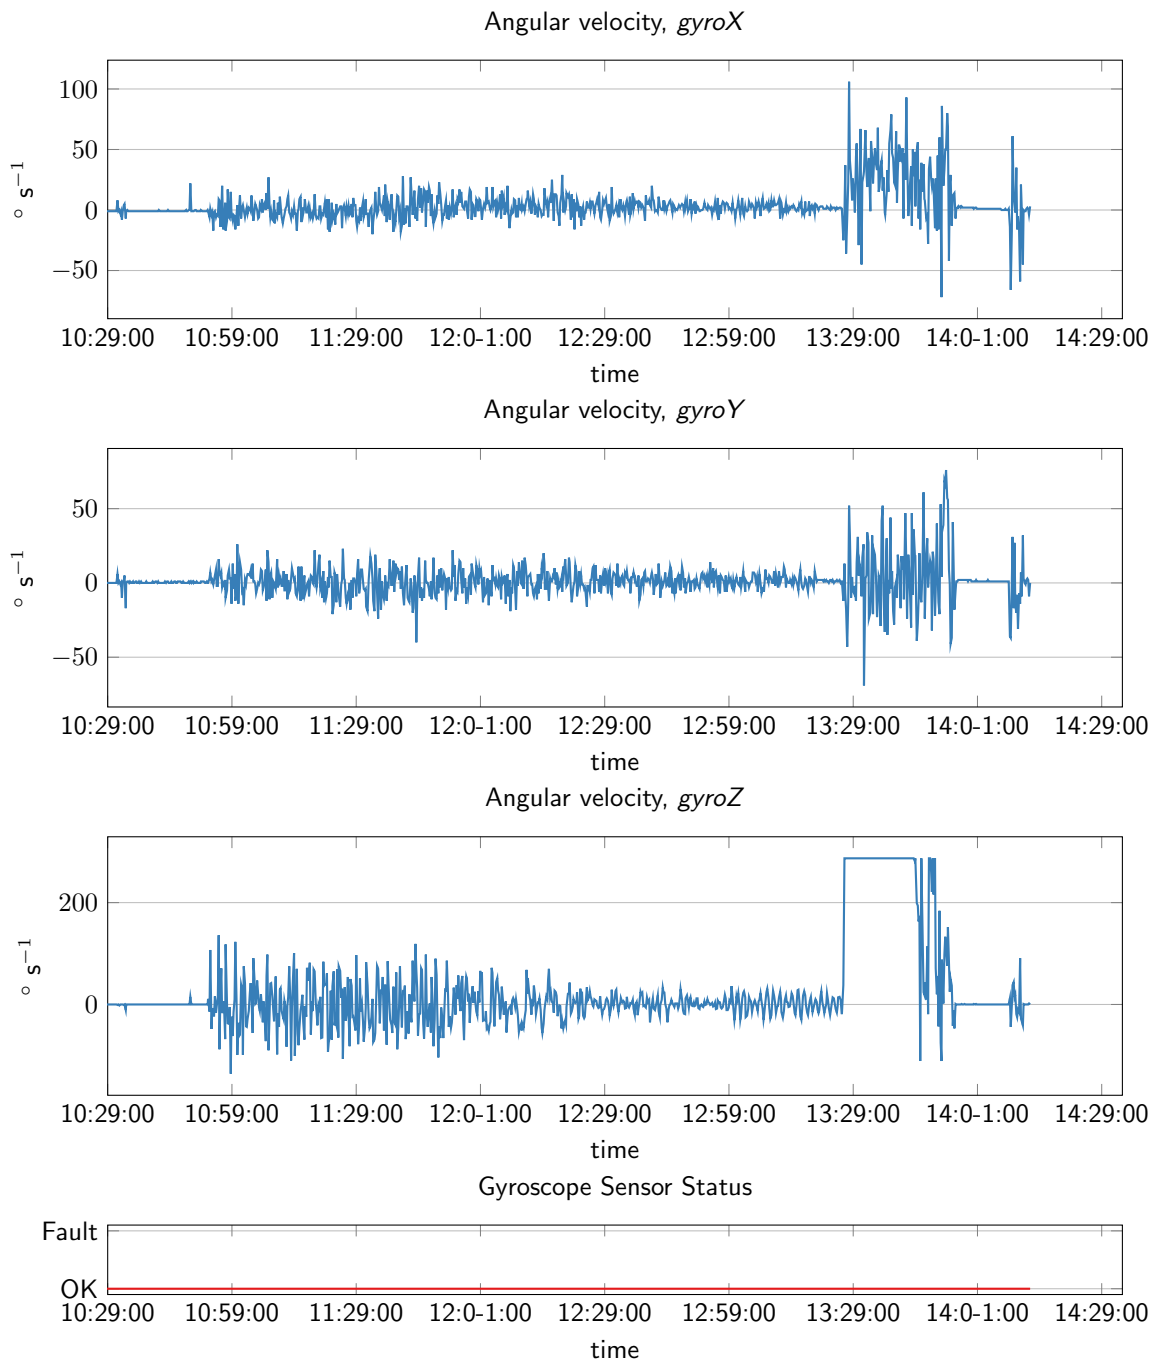
Figure 35: Raw logged data of gyroscope sensor. Last plot sensor status.
